Morphodynamic and vulnerability analysis of the coastline during the period 1991 - 2023 by means of geotechnologies in Jambelí Island, Santa Rosa Canton, El Oro

Brayan Contreras Vargas

Acta Oceanográfica del Pacífico

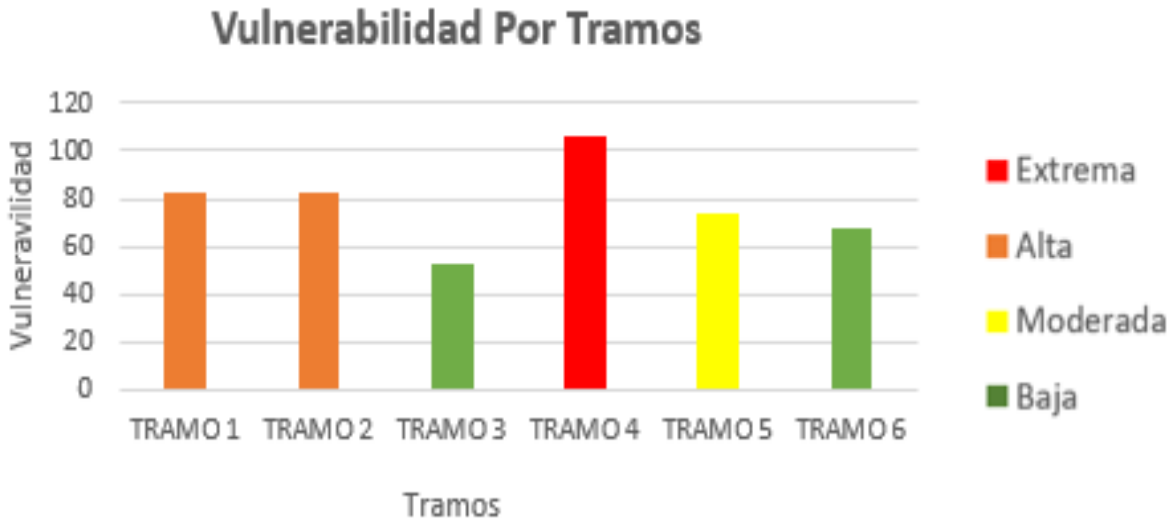
Figure. 7 Shows the degree of vulnerability of each reach according to a color chart. The red color represents extreme coastal vulnerability, which includes section 4; the orange color represents the high vulnerability sections, which include sections 1 and 2; the yellow color represents moderate vulnerability and corresponds to section 5, while the green color

represents low vulnerability and can be observed in sections 3 and 6, this low vulnerability is due to anthropic influences

present in section 3 and the presence of mangroves and gentle currents that generate deposits in section 6.

Figure 7. Vulnerability analyzed by sections.
